Preliminary Assessment

Kittridge Distribution Center
4959 NW Front Avenue
Portland, Oregon

Prepared for
Schnitzer Investment Corp.

April 5, 2000

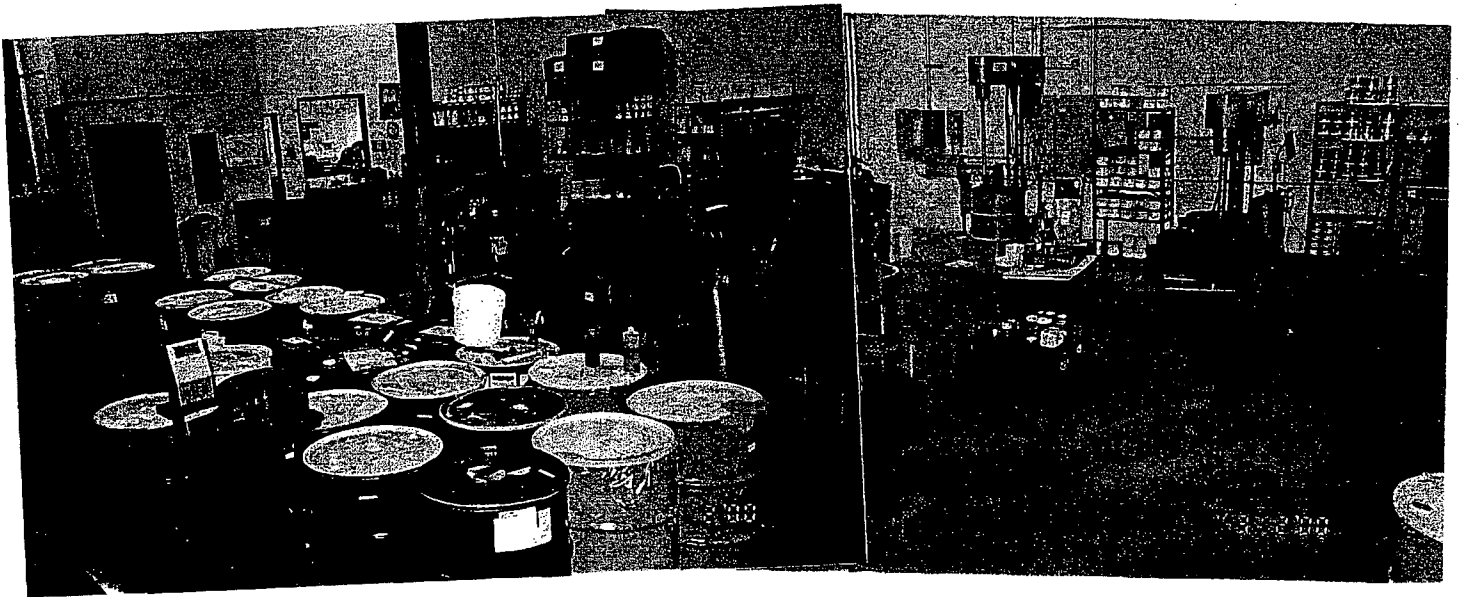
Photo No. 9

Inks are mixed in two ink mills located near the center of the Colour Systems space. The mills are water-cooled with a 10 ft by 3 ft by 2 ft-deep water trough serving as a water cooling bed. Some ink staining was observed around the base of the ink mills. Given the lack of floor cracks or floor drains, the staining does not indicate releases to the underlying soil. No evidence of spills from the water-cooling system was observed.

profile information provided by the facility personnel, the waste is designated as non-hazardous. Safety Kleen is contracted to properly dispose of the waste offsite. There was no evidence of releases observed in the Colour Systems space. No ink or solvent wastes are discharged to the sanitary sewer.

Interior of Colour Systems.

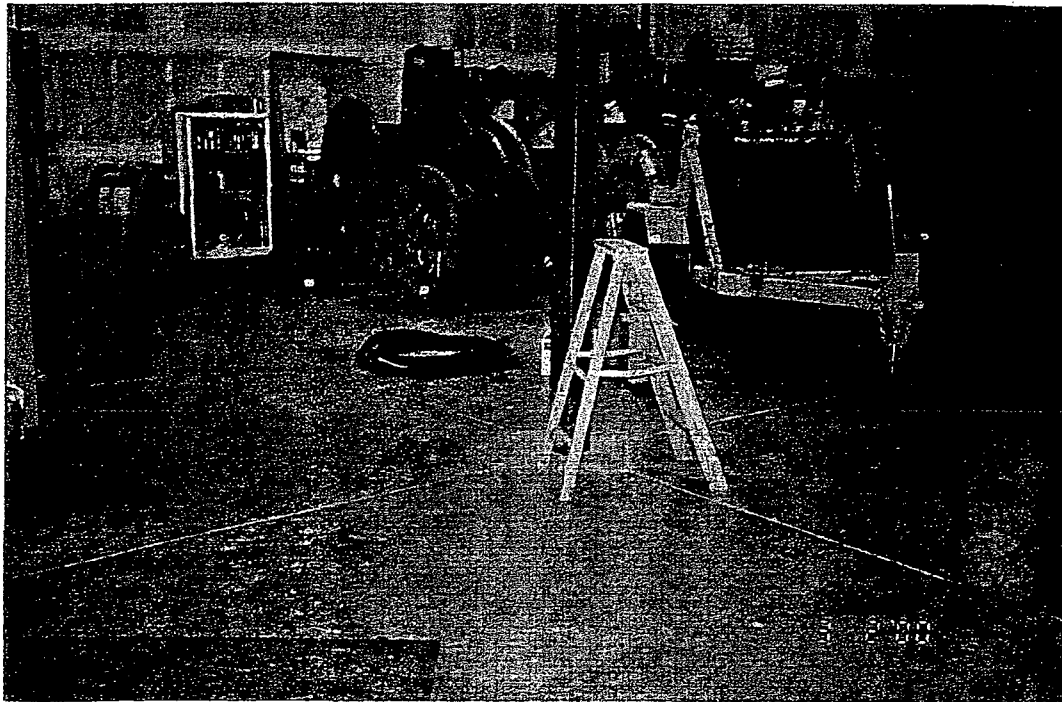
Photo No. 10

The WorldCom space is used as a general equipment and supply storage area in support of WorldCom's maintenance of telecommunication cables in the Portland area. Trailer-mounted generators and large spools of telecommunication cables are stored in the approximately 5,800 square foot space. No equipment maintenance is performed in the space and hazardous substances are limited to small quantities (less than 5-gallons) of lubricant oil, gasoline, antifreeze, and non-chlorinated solvents stored in a fire-proof cabinet. The floor was clean and no floor cracks or floor drains were observed. No evidence of spills or releases of hazardous substances was observed in the WorldCom space.

Interior of WorldCom.

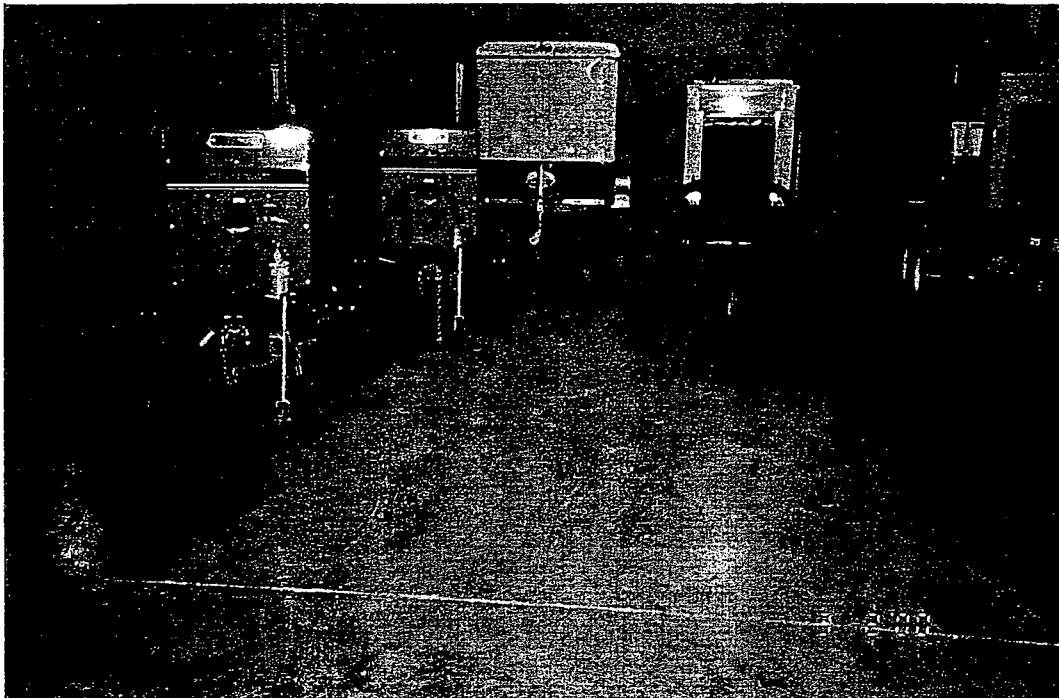
Photo No. 11

Interior of WorldCom.

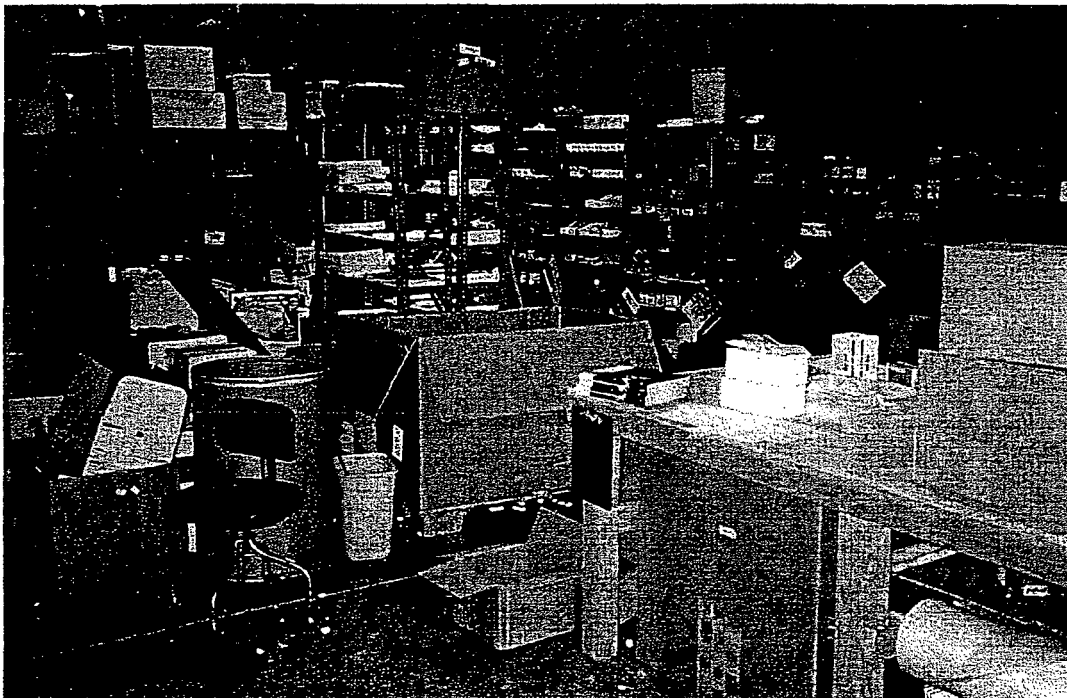
Photo No. 12

04 Controls receives and distributes small electrical switching components. Personnel computer equipment and cables are also stored in the approximately 4,900 square-foot 04 Controls space. No equipment maintenance or assembly is performed in the space. Hazardous substances are limited to household quantities of cleaning supplies. The floor was clean and no floor cracks or floor drains were observed. No evidence of spills or releases of hazardous substances was observed in the 04 Controls space.

Interior of 04 Controls.

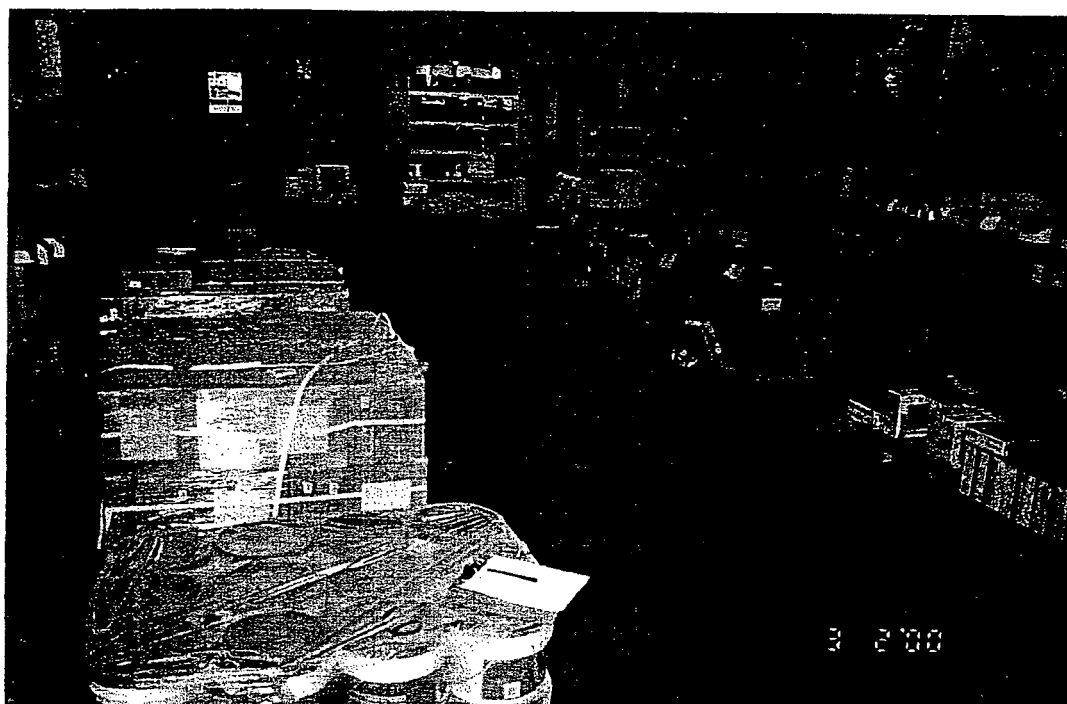
Photo No: 13

Uniq Distributing receives and distributes decorative household tile and tile installation supplies to builders and contractors. In addition to numerous cases of ceramic tiles, floor caulking and tile adhesive are neatly stored on shelves and pallets in the approximately 5,500 square-foot space. No manufacturing occurs in the space and no materials are repackaged. The floor was clean and no floor cracks or floor drains were observed. No evidence of spills or releases of hazardous substances was observed in the Uniq Distributing space.

Interior of Uniq Distribution.

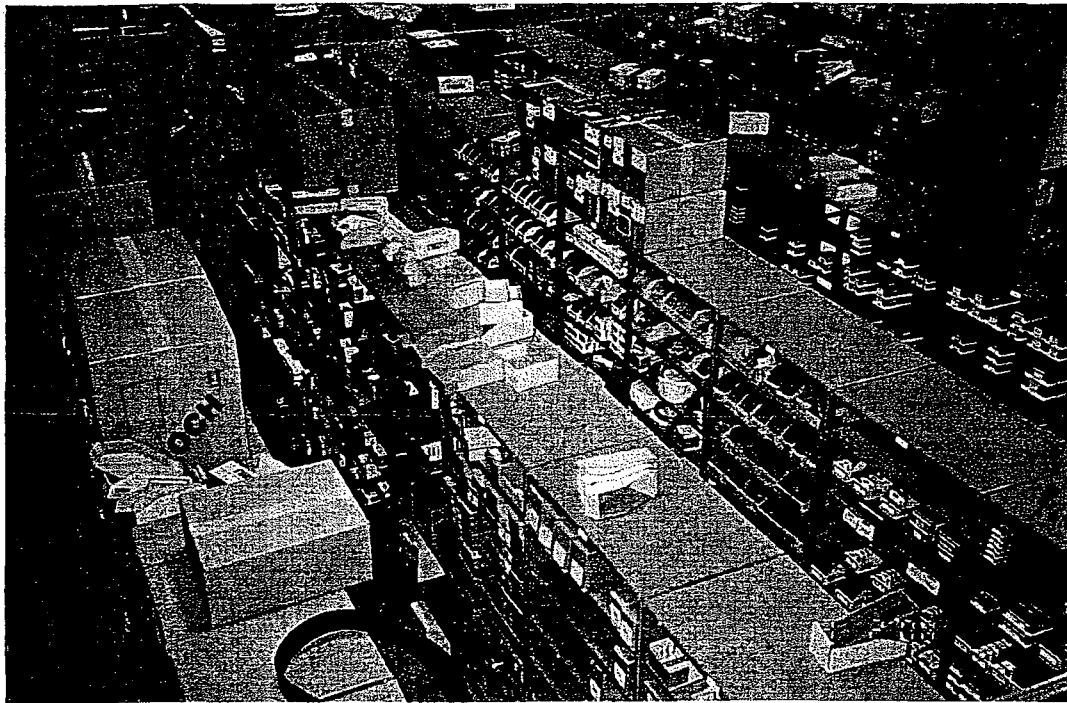
Photo No. 14

The floor was clean and no floor cracks or floor drains were observed. No evidence of spills or releases of hazardous substances was observed in the Applied Industrial Technologies space.

Interior of Applied Industrial Technologies

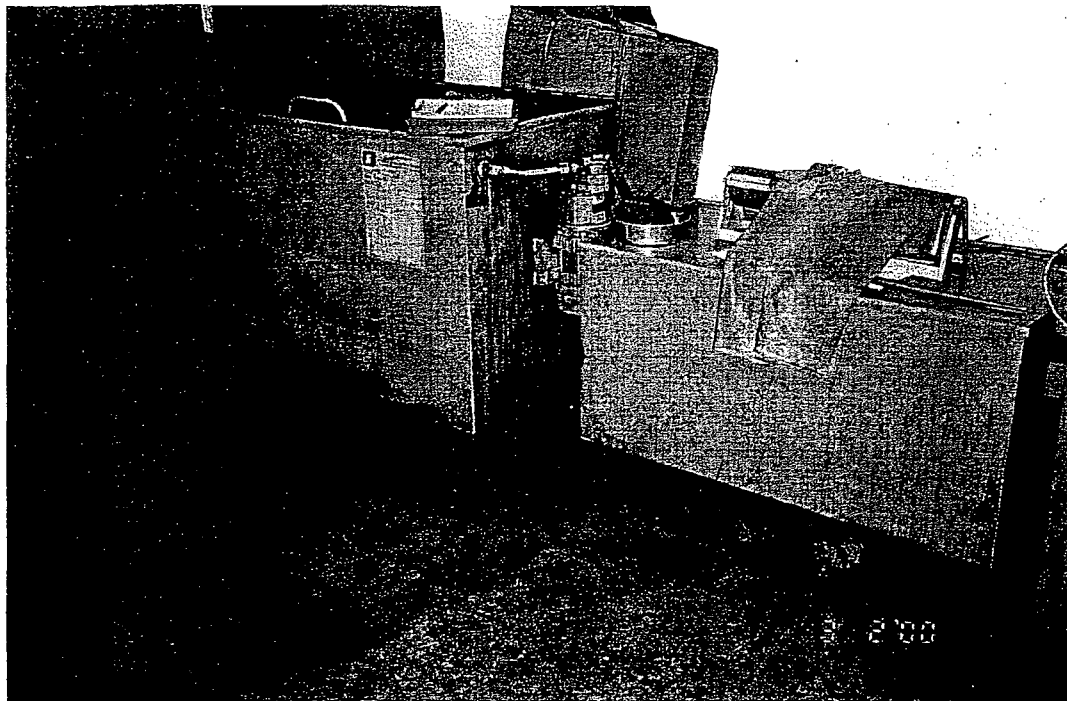
Photo No: 15

Two Safety-Kleen cleaning tanks were observed along the southern wall of the Applied Industrial Technologies space. Facility personnel noted that the tanks are used to clean bearings for customers. Safety-Kleen regularly services the cleaners and manages the wastes off site. No evidence of spills or releases was observed around the two cleaning tanks.

Safety Kleen bearing washers in Applied Industrial Technologies.

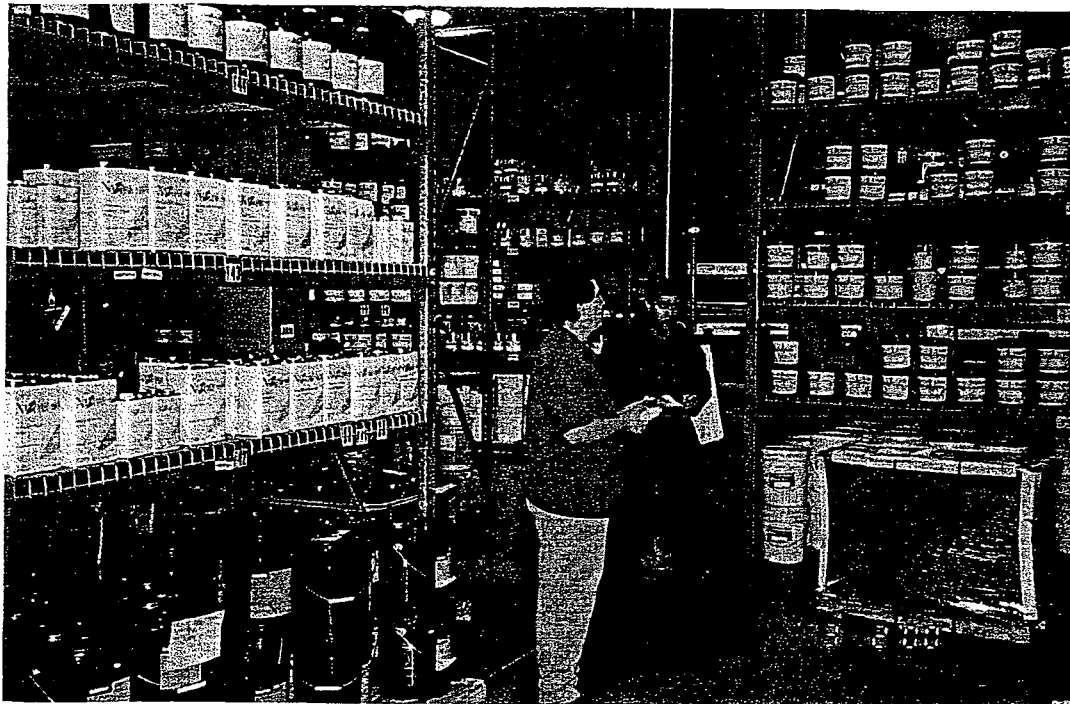
Photo No. 16

Midwest Signs receives and distributes printing and graphic supplies for a wide-range of print media service providers. Several hundred containers of oil-based and water-based inks and solvents are neatly stored on pallets and shelves in the space. No materials are mixed or repackaged in the approximately 13,100 square-foot space. No manufacturing occurs in the space and containers are not opened. A brief review of the several hundred MSDS's on file at the facility noted organic solvents, acetone, toluene, and oil-based solvents. Other than small aerosol cans of cleaners, no chlorinated solvents were observed in the space. The floor was clean and no floor cracks or floor drains were observed. No evidence of spills or releases of hazardous substances was observed in the Midwest Signs space.

Interior of Midwest Signs.

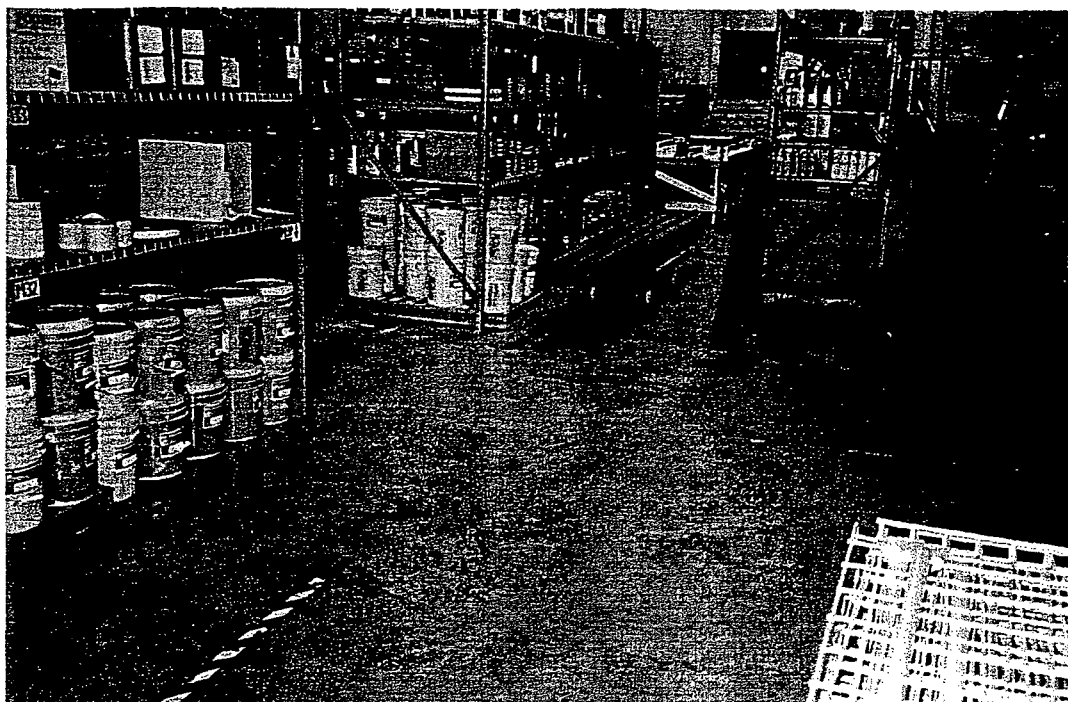
Photo No: 17

Interior of Midwest Signs.

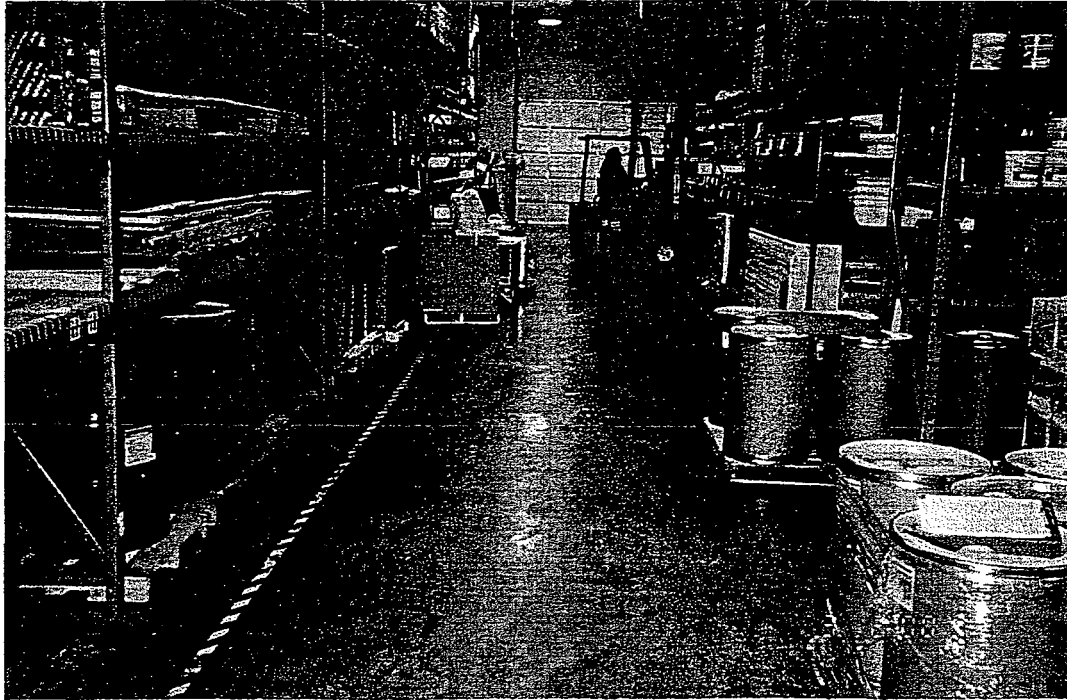
Photo No. 18

Interior of Midwest Signs.

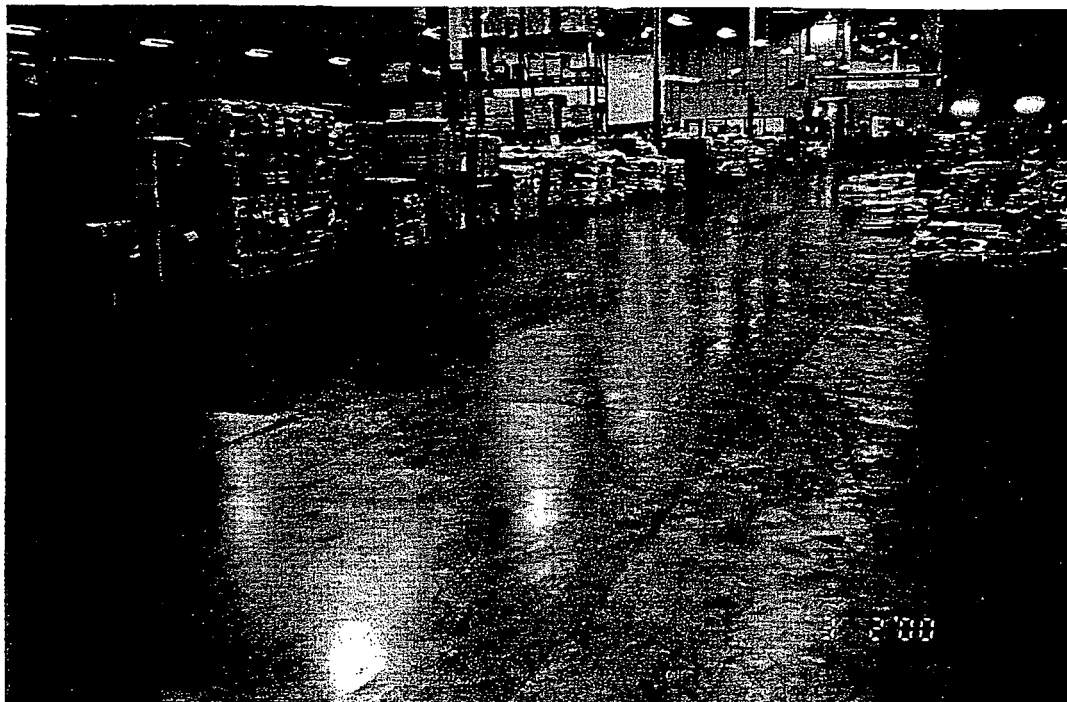
Photo No: 19

No evidence of spills or releases of hazardous substances was observed in the Oregonian space.

Looking west from east of interior of Oregonian space.

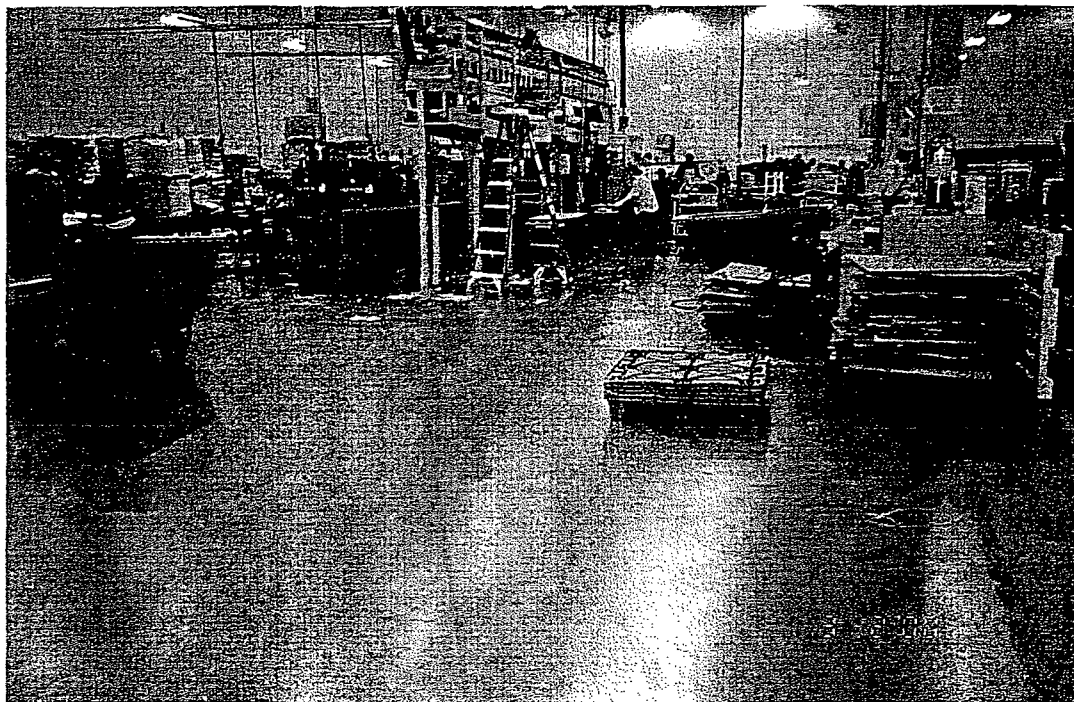
Photo No. 20

Two floor drains are located near the air compressors, along the western wall of the space. Lines conveying water drained from the air compressors drain into the floor drains. One of the floor drains is also used to drain the floor cleaning equipment after each use. Facility personnel noted that the floor drains are connected to the City of Portland sewer systems. Some discoloration was observed around the lines draining the air compressors. No floor cracks or other floor distress was observed in the area around the air compressors or in any other portion of the Oregonian space.

Looking west at west end of interior of Oregonian space.
